April 19, 2019  
G5019

SUBJECT: **Geotechnical Feasibility Study -DRAFT-**  
RE: Mar Vista Hotel, Hostel & Stables  
Daly City, California

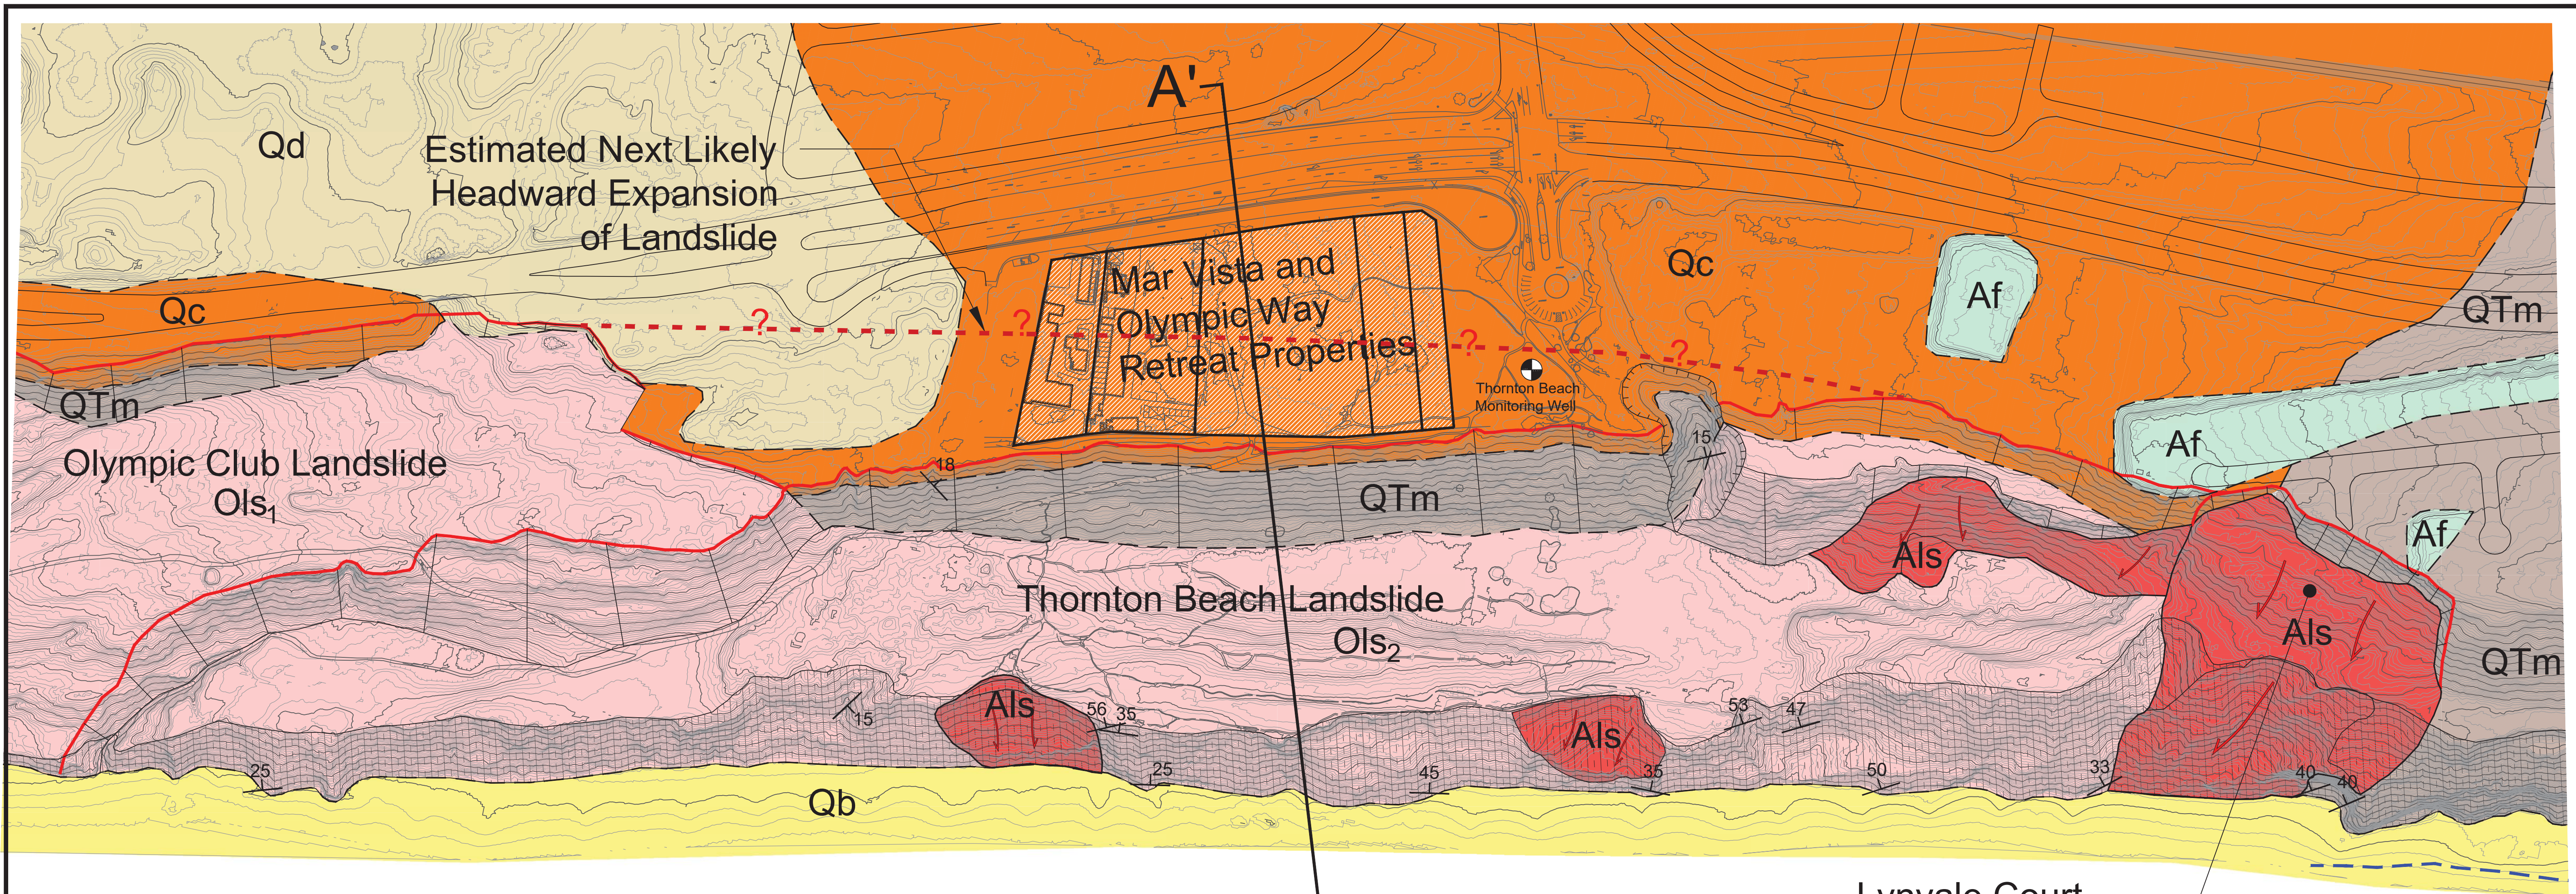
<b>COTTON, SHIRES AND ASSOCIATES, INC.</b> CONSULTING ENGINEERS AND GEOLOGISTS		
<b>ENGINEERING GEOLOGIC MAP</b>		
<b>MAR VISTA</b>		
DALY CITY, CALIFORNIA		
GEO/ENG BY AM	SCALE 1"=150'	PROJECT NO. G5019
APPROVED BY JW	DATE April 2019	FIGURE NO. 3

The Thornton Beach Landslide, characterized by a very large, down-dropped and back-rotated landslide block, is located immediately downslope from the subject properties, and has been recognized as large landslide complex for over 100 years. The landslide extends along the coastline for a distance of approximately 4,000 feet, and has an average width of approximately 450 feet downslope of the Mar Vista property. The landslide block contains a lower bluff face, approximately 100 feet in height, with precipitously steep slopes up to approximately 35- to 45-degree inclinations. This lower bluff face is exposed to coastal wave attack. An upper bluff face rises above the landslide block, and is characterized by a 120-foot high, very steep bluff face. Coastal bluff average long-term retreat rates for this portion of the coastline have been documented to be approximately 1 foot per year. We note that this long-term average bluff retreat rate was likely calculated for the top of the lower bluff face.

Landsliding presents the most significant geologic hazard to the subject site. The potential for headward (landward) advancement upslope from the large Thornton Beach Landslide appears to be the most likely landslide mechanism to impact the subject site. The Thornton Beach Landslide is a deep rotational slump type landslide that is thought to have developed as recently as 400 years ago (Liebhardt, 2002). The Thornton Beach Landslide is depicted on our Engineering Geologic Map of the site as Ols2 (Figure 3). In addition to the Thornton Beach Landslide, a complex of several large landslides is located to the north of the subject site. We have grouped these slides together and refer to them as the Olympic Club Landslide (Ols1 on Figure 3). The Olympic Club Landslide appears to have advanced southward over time. During our site reconnaissance we observed relatively small (6 to 8 foot tall) scarps at the southern end of the Olympic Club Landslide. The most recent landslide affecting the area occurred in the early 1970s along the southern end of the Thornton Beach Landslide. This landslide is known as the Lynvale Court Landslide, named after the residential cul-de-sac that it truncated, eventually forcing the demolition of six houses.

The mechanism that will eventually cause headward migration of the Thornton Beach Landslide is the removal of buttressing material at the toe of the landslide due to coastal erosion of the lower bluff face by wave action associated with high surf and winter storms. The bluff subject to this type of erosion is depicted on our Engineering Geologic Map. The bluff retreat rate for this lower bluff has been estimated to be 13 inches per year (Griggs, 2005). Over a 75 year design life of a structure this would equate to over 80 feet of retreat of this lower bluff.

plotted an arcuate failure surface on our Engineering Geologic Map to determine if a new headscarp 150 to 200 feet inland could produce a reasonable landslide geometry and if that geometry was similar to what we see in the existing landslide. This estimated future headward expansion is shown on both the Engineering Geologic Map (Figure 3) and on Engineering Geologic Cross Section A-A' (Figure 4). It should be noted that the northern limit of the estimated future headward expansion was shifted inland to account for the potential influence of the southward expansion of the Olympic Club Landslide.

Based on this study and the previous slope stability analysis, it is our opinion that the line depicted on our Engineering Geologic Map is a preliminary estimate of a likely failure line, but should not be used to guide setback criteria at this time. This line is our best estimate of an appropriate setback from the limit of future landward advancement of the headscarp of the landslide. **This line does not represent a factor of safety of 1.5.** The only way to develop a building setback line for use in design is to perform a detailed site investigation including detailed mapping, subsurface exploration, laboratory testing and slope stability analysis. Such an investigation could generate a factor of safety line of 1.5 that shifts the potential building envelope farther from the bluff or closer to the bluff.

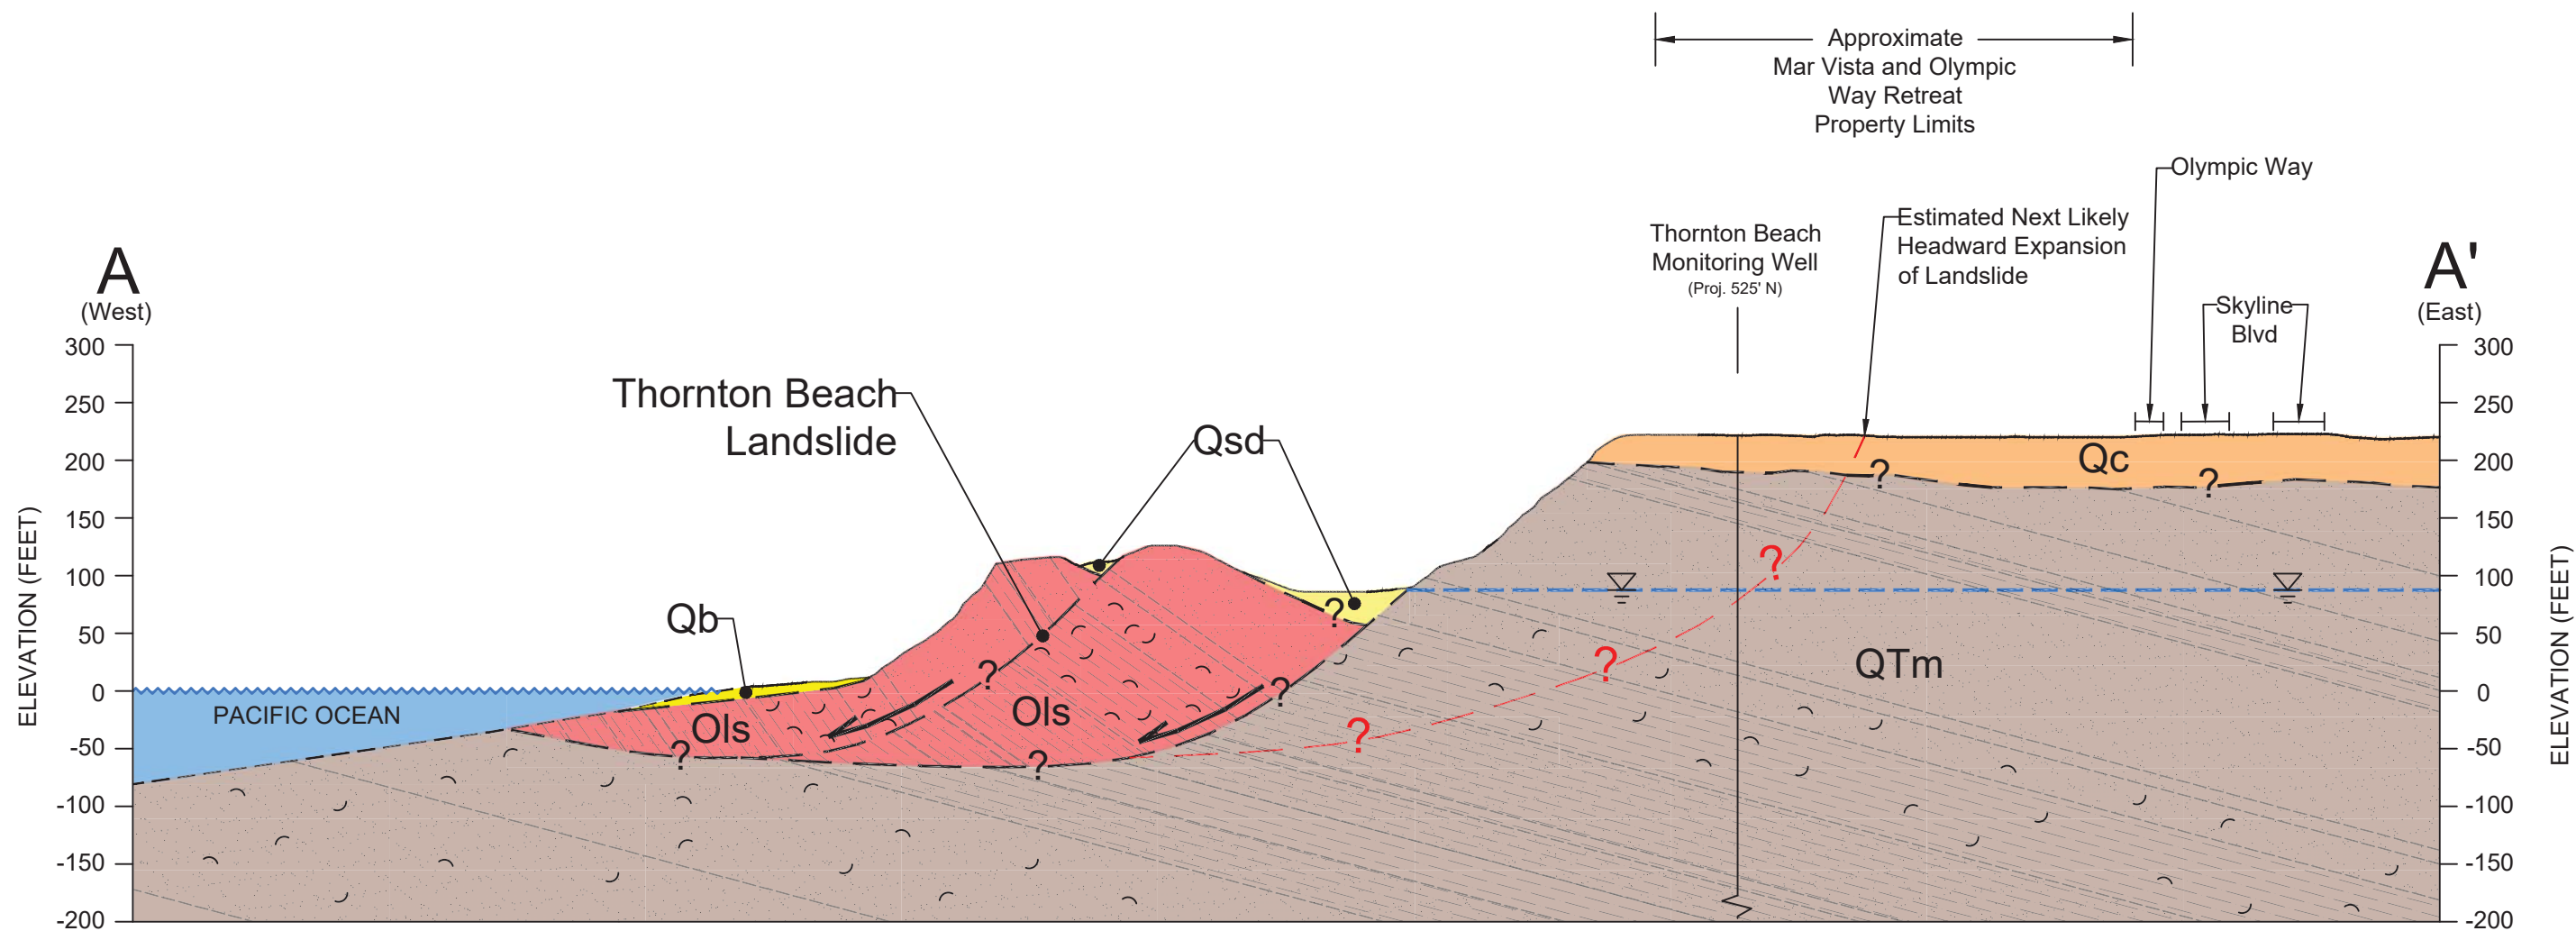
### ENGINEERING GEOLOGIC CROSS SECTION A-A'

In order to evaluate the impact of headward advancement upslope from the Thornton Beach Landslide on the subject properties, we developed Engineering Geologic Cross Section A-A' (Figure 4). Utilizing the subsurface data available from the Thornton Beach Monitoring Well, and following previous analysis done of the slide by Bonilla (1960), we attempted to correlate geologic units described in the monitoring well log with geologic units observed in the field within the displaced landslide blocks. Based on our analysis, there appear to be two major events of rotational slumping of the large Thornton Beach Landslide block that are preserved in the field today. The geomorphic expression of these events include the north-south oriented ridges that form closed depressions on their landward side, and variably dipping bedrock units across discrete landslide blocks. The width of the most recent rotational slump block (approximately 150 to 200 feet) can serve as an approximate analog for the potential width of a future event. Based on this analysis we determined that a likely width of a future failure could be approximately 150 to 200 feet from the current headscarp/top of bluff. Once we developed this width we
