**SKYLINE BLUFFS
DALY CITY, CALIFORNIA**

GEOTECHNICAL FEASIBILITY REPORT

February 12, 2019

8438.001.000

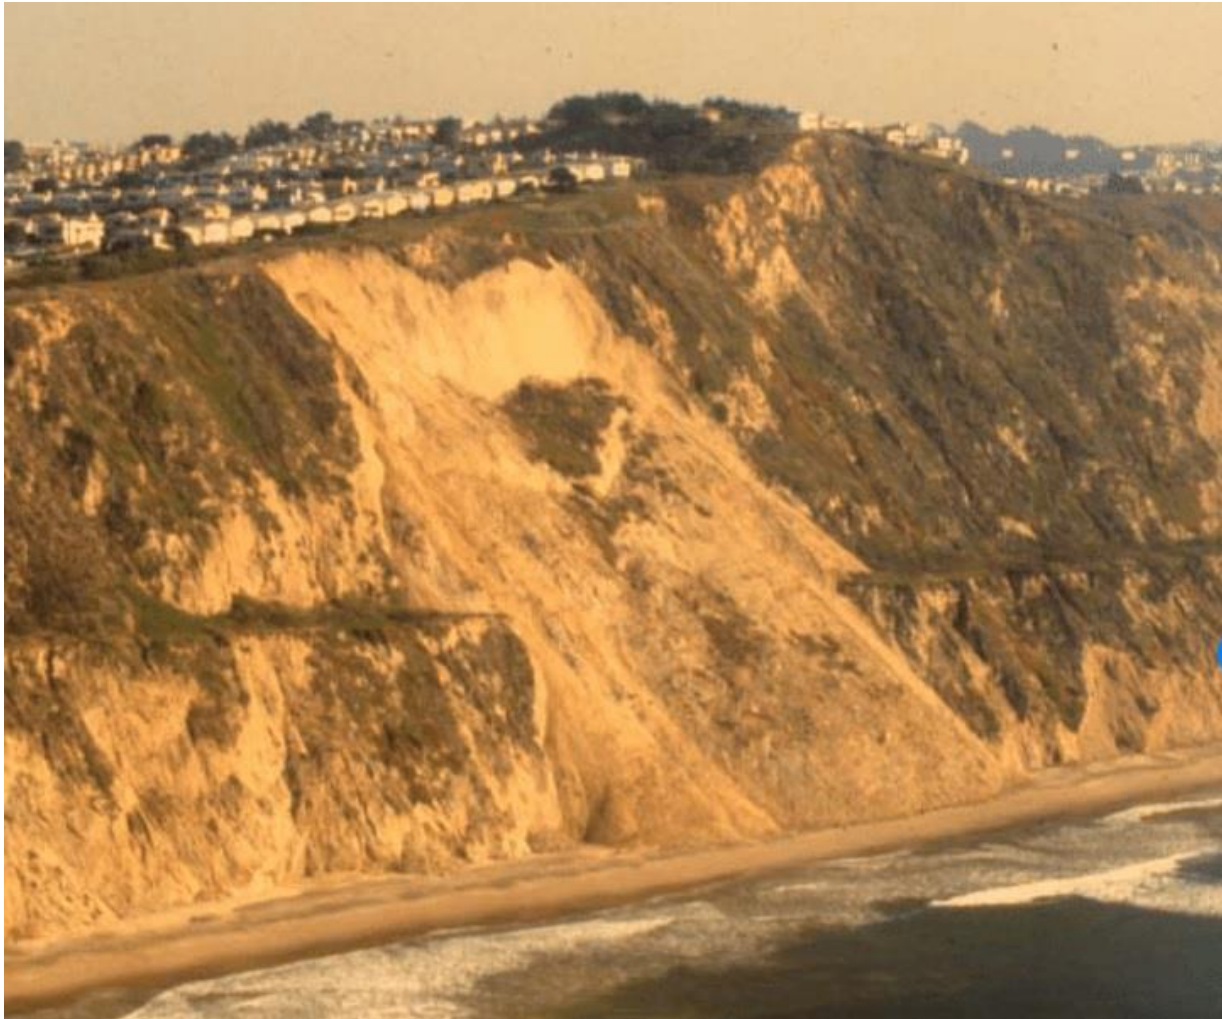
During the 1989 Loma Prieta Earthquake, a relatively large, seismically triggered bluff failure occurred in the slopes west of Palisade Drive, about 3,500 feet south of the site.

FIGURE 2.1.1: Large (approximately 4-acre) Seismically Induced Bluff Failure West of Palisade Drive, 1989

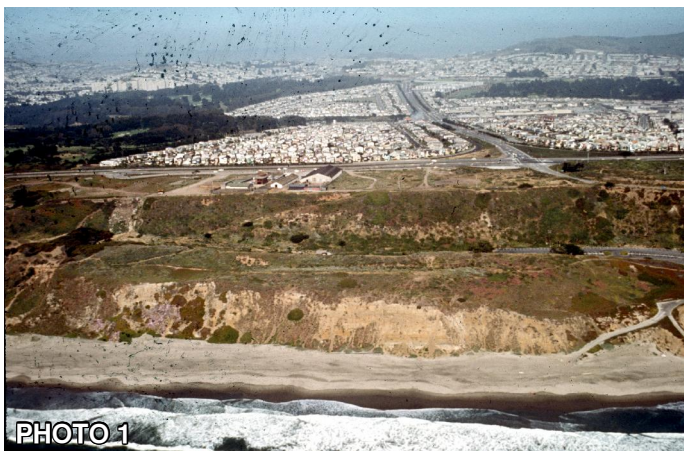
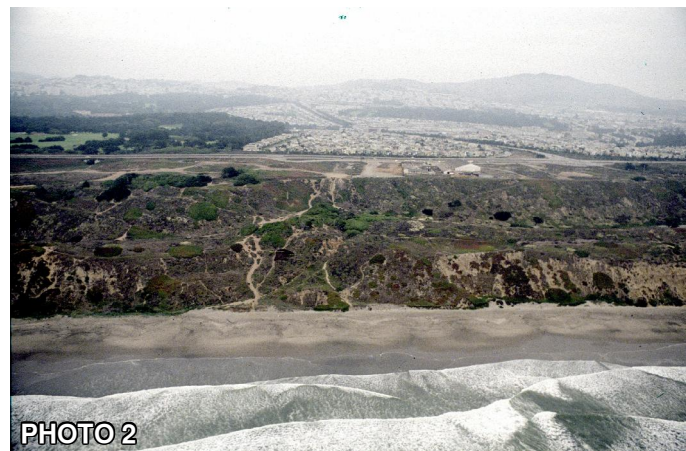
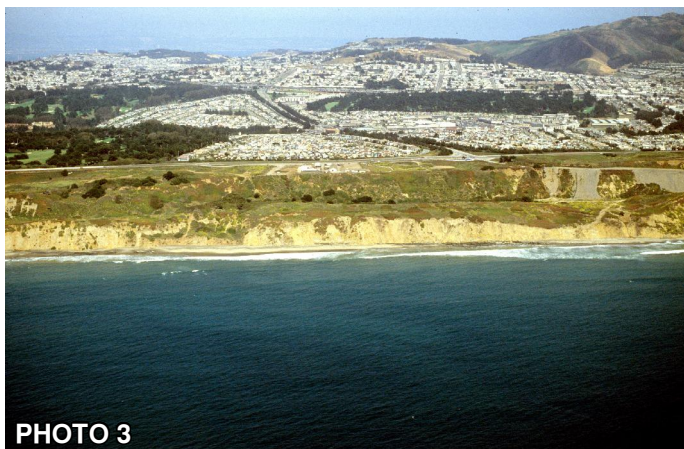
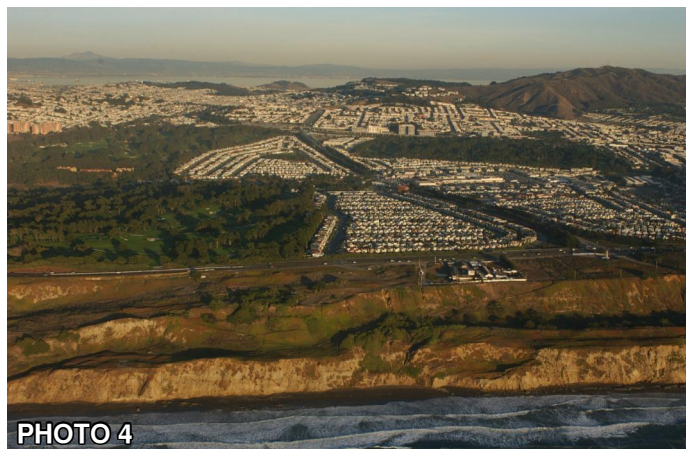
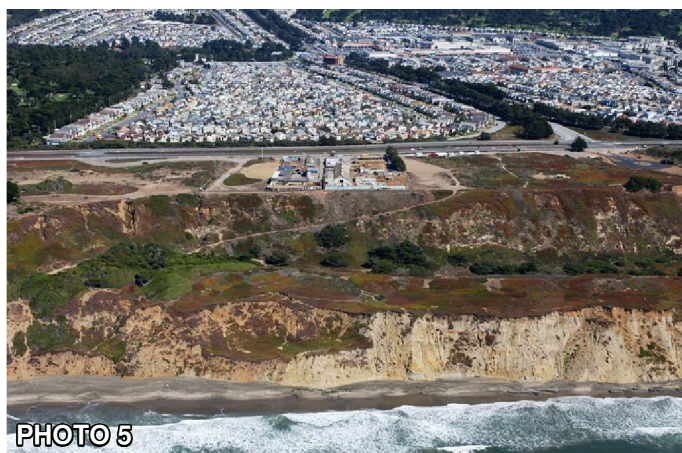
We reviewed stereo-paired aerial photographs of the site dated 1935 through 2001 (Figures 5A through 5G) and oblique photographs from the California Coastal Records project from 1972 to 2013 (Figures 6A and 6B). Review of these images indicates that in 1935 the site and an area on the landslide terrace below the site to the west appears to have been used as agricultural land. The existing stables were built between 1935 and 1943, in addition to structures on the southern two parcels. Improvements on the southern two parcels were removed between 1943 and 1965. A paved parking area was constructed on the landslide terrace west of the property between 1946 and 1965, with entry from John Daly Blvd. The parking area on the landslide terrace was demolished in 1983. According to various news article archives, the extension of John Daly Blvd. leading to the parking area was destroyed in a landslide in the 1982-1983 El Nino storms, and was not repaired. The aerial images show that much of the coastal bluff was sporadically vegetated prior to the early 1990s. In the 1993 aerial image, erosion and landslide failures in the coastal bluff appear to have accelerated, and erosion and landslide recession have continued to the present day.

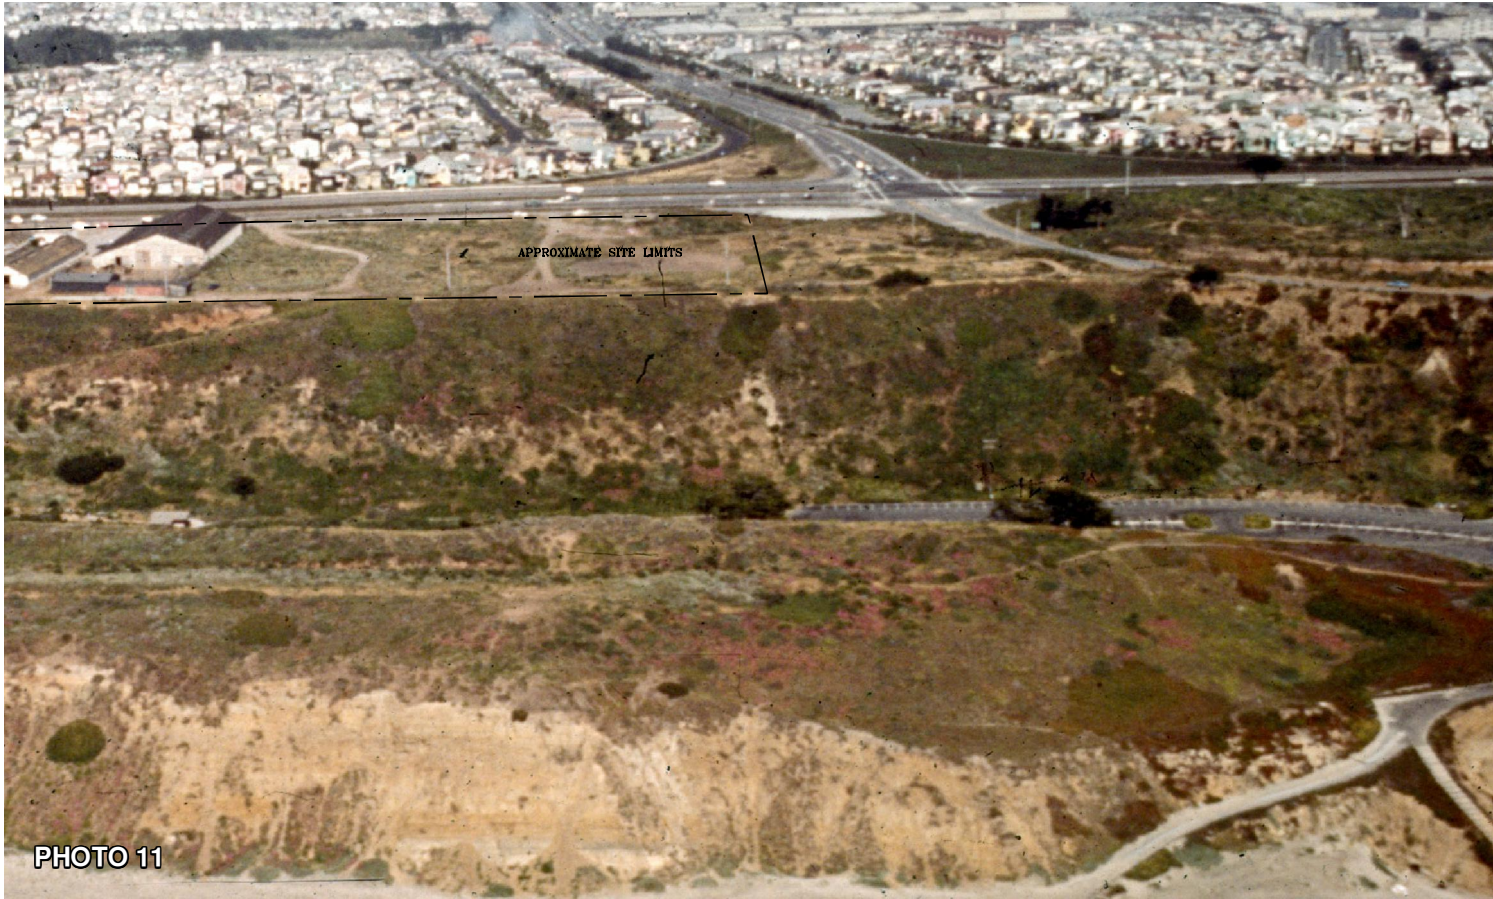
During the El Nino storms of 1982-1983, about 130 feet of the John Daly Extension Road, which formerly led to a parking area directly below the property on the landslide terrace, were lost to

landslide movement and subsequent gully erosion. The road to the parking lot on the landslide terrace dropped approximately 7 meters due to movement on the Thornton Beach Landslide (Lajoie and Mathieson, 1998).

JOHN DALY BLVD EXTENSION AND PARKING LOT, 1972

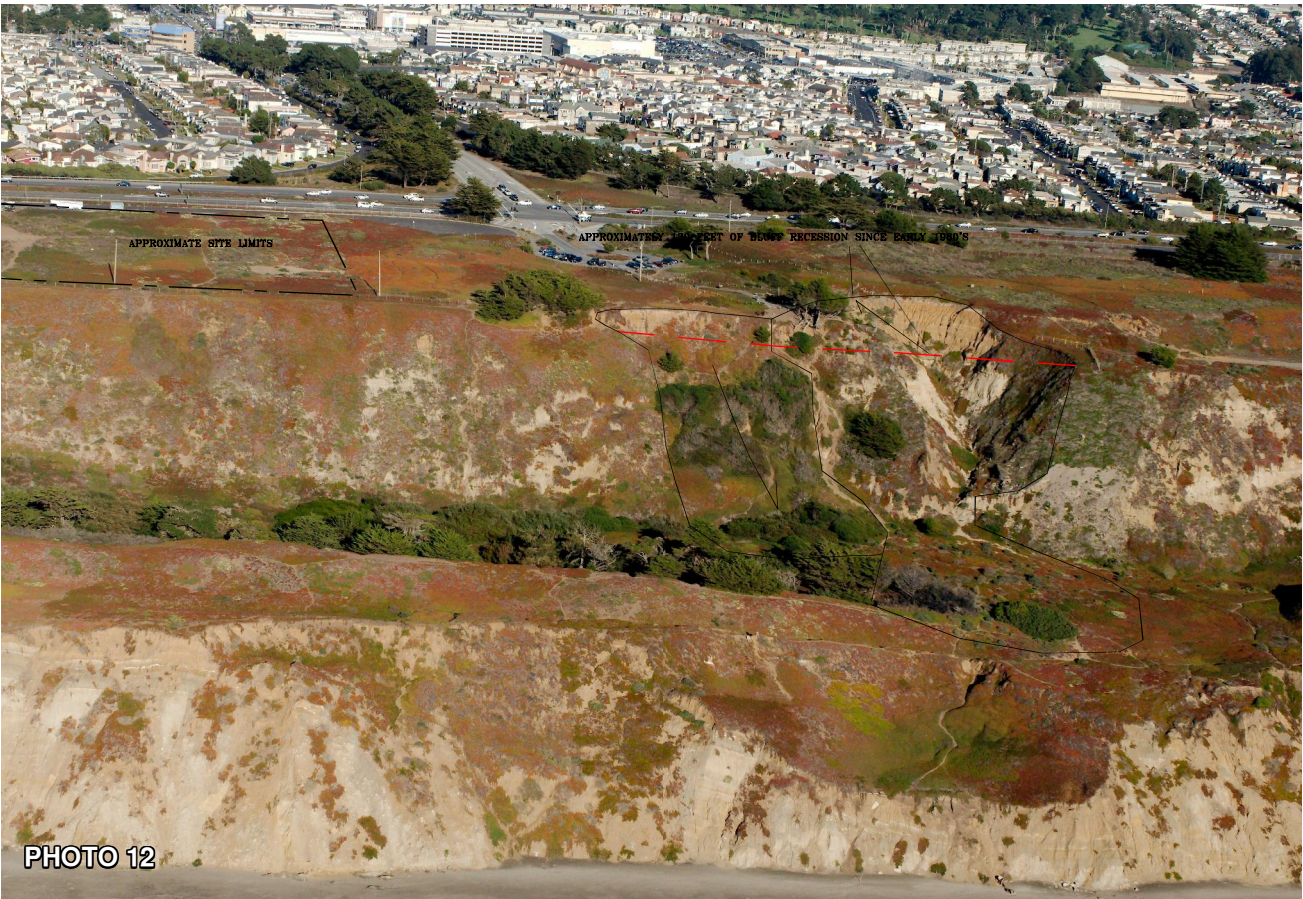
JOHN DALY BLVD EXTENSION AREA, 2013

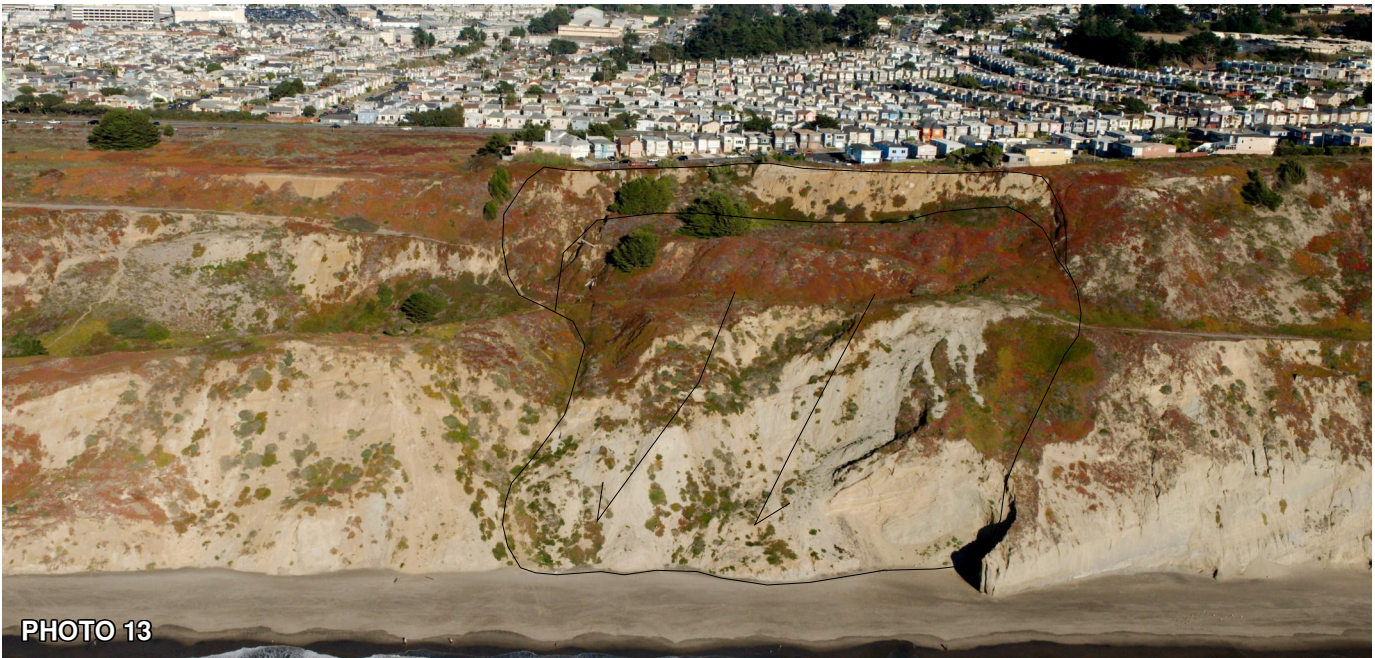
In 1974, Caltrans prepared a study of damage to the roadway on the former railroad bed about 1,700 feet south of the site below Lynvale Court and the end of Skyline Drive. According to the study, slope cracking and movement was noted in 1972 in Lynvale Court and the end of Skyline Drive about 100 feet east of the bluff face. Eventually, about 50 feet of Lynvale Court was lost and four houses were removed. In February 2004, a storm caused further erosion along the neighborhoods of Skyline Drive, Lynvale Court and Rosalyn Court, resulting in one home being removed from Skyline Drive (Fradkin, Philip L, 2011).

LYNVALE COURT LANDSLIDE, 2013

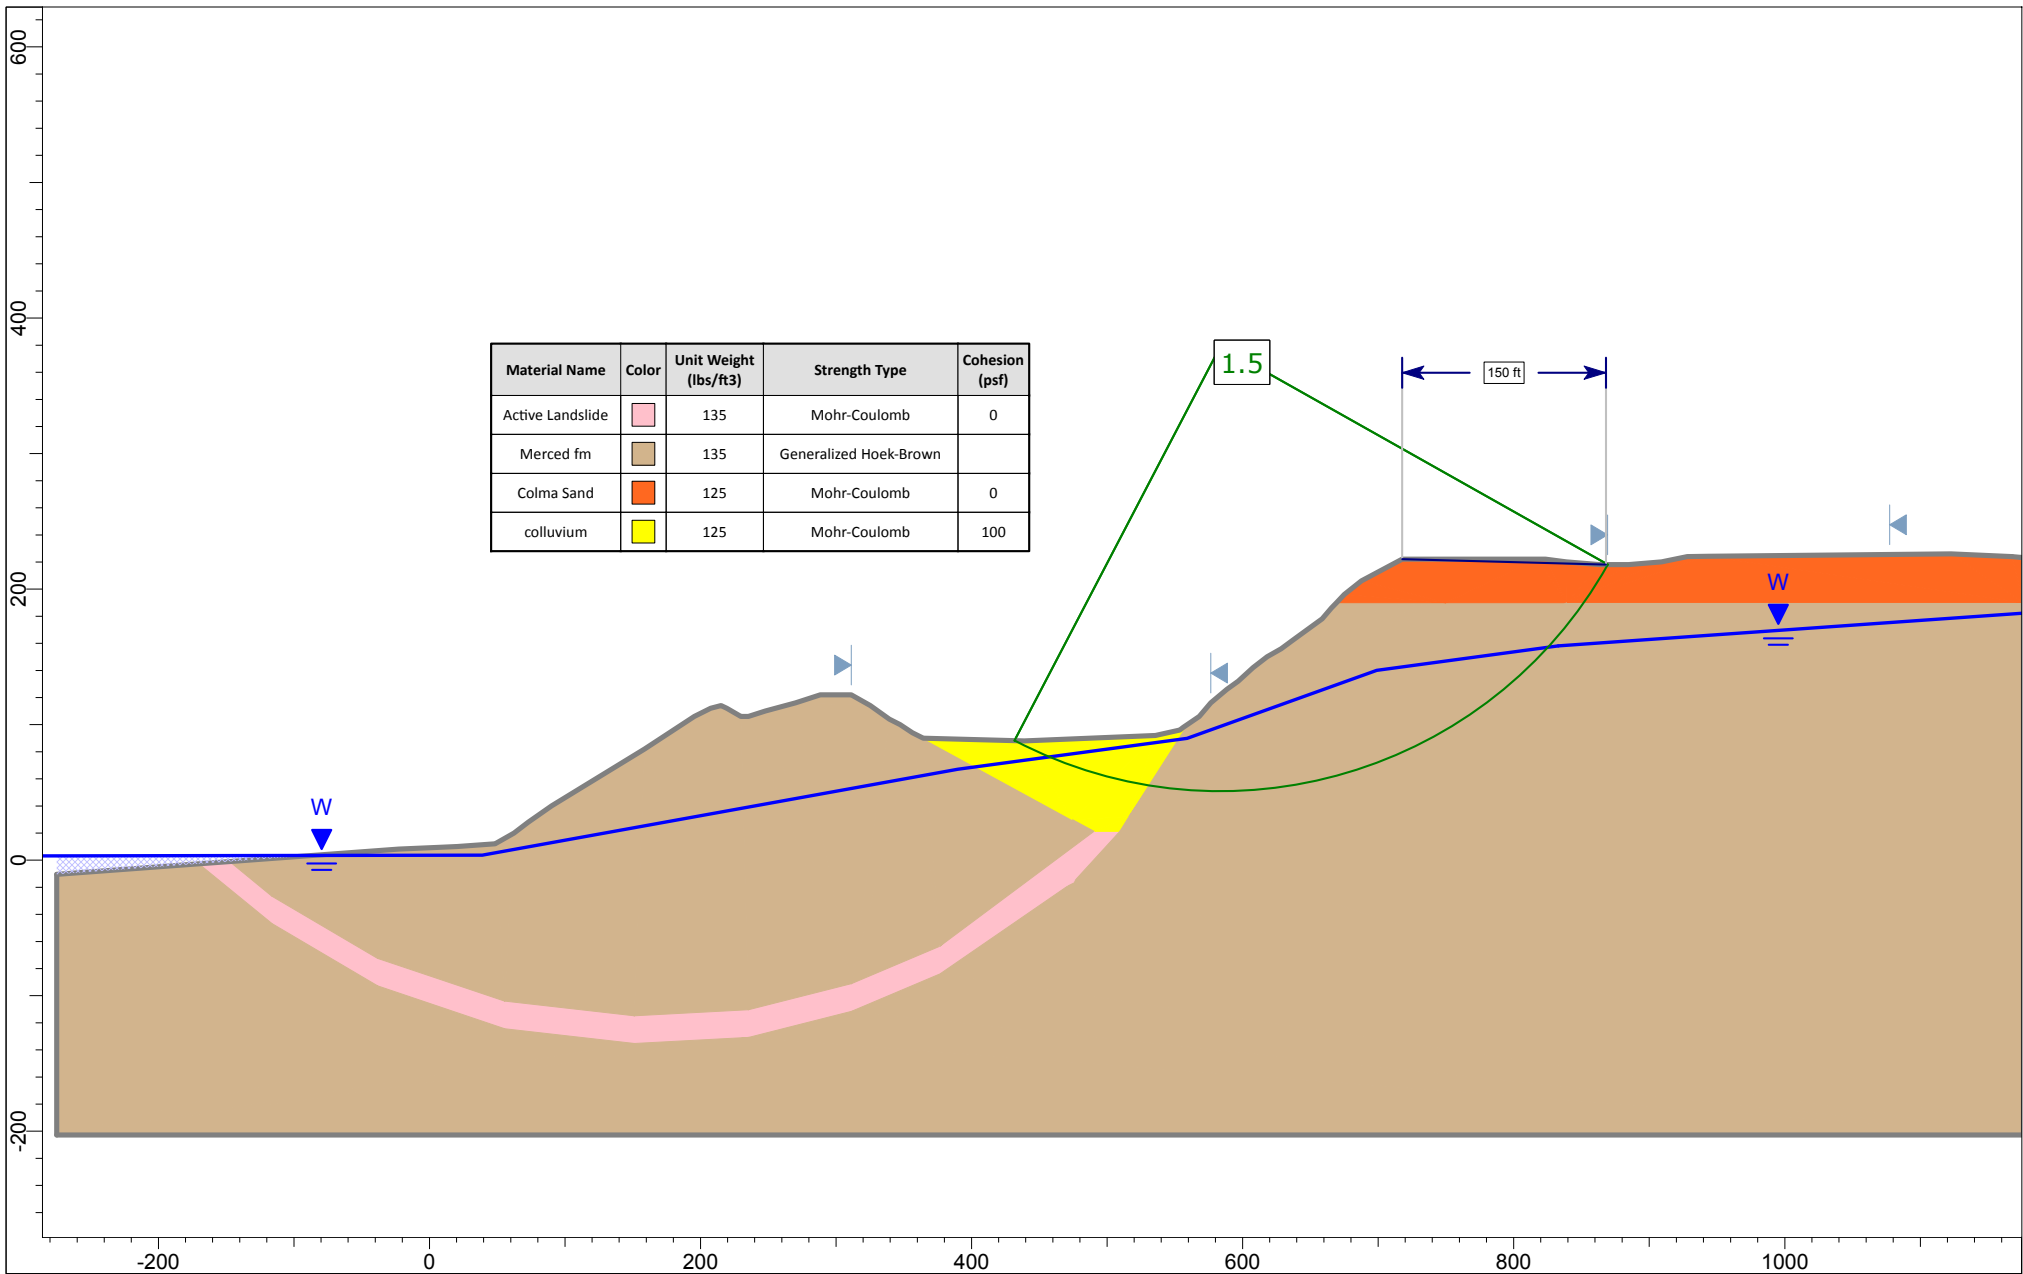
ENGEO Expect Excellence <small>SLIDEINTERPRET 8.021</small>	Project			SECTION C-C' : Skyline Bluffs	
	Scale	1:1700	Author	PS	Project No.
	Date	February 7, 2019	Condition	Static Analysis	8438.001.000

We constructed Cross Section C-C' at the southern edge of the property to estimate relative slope stability at the highest portion of the bluff fronting the property. Geologic interpretations are based on published information from Bonilla, (1960). As noted above and depicted on Figure 4, the bluff face is currently mantled with shallow to moderate depth surficial landslides and slope wash. Based on the assumptions described above, the calculated static factor of safety is below 1.5 for the land within a distance of approximately 150 feet east from the top of the bluff. The results of slope stability analyses of Section C-C' are depicted in the slope stability output file in Appendix A.

Preliminary slope stability analyses of Cross Section C-C' result in hypothetical circular failure surfaces that are of similar depth and geometry. Based on these preliminary analyses, at least 150 feet of the ground east of the top of the existing bluff should be considered potentially unstable and subject to slope failures. If a significant bluff failure occurs, it will likely be necessary to protect adjacent improvements from additional regression by constructing some form of structural retention measure such as a soldier pile wall or and anchored soil nail wall. We therefore recommend that, for preliminary planning purposes, you consider leaving an additional 50-foot-wide undeveloped zone that will allow access between the bluff and improvement for construction of supplemental stabilization measures. Based on these considerations, we recommend a minimum 200-foot-wide setback from the top of the bluff for any significant improvements such as habitable structures, major utilities, and essential access roadways. As noted above, our analyses were limited to static (non-seismic) conditions. The design-level geotechnical report will need to consider seismic slope stability as well as static slope stability. As describe above, the preliminary and simplified assumptions made for this study do not provide a basis for performing a technically reasonable seismic slope stability analysis. If you decide to proceed with site development planning, it will be necessary to perform a more comprehensive geotechnical study including subsurface investigations and supplemental analyses. We provide a preliminary supplemental investigation scope below.
