April 19, 2019  
G5019

SUBJECT: **Geotechnical Feasibility Study -DRAFT-**  
RE: Mar Vista Hotel, Hostel & Stables  
Daly City, California

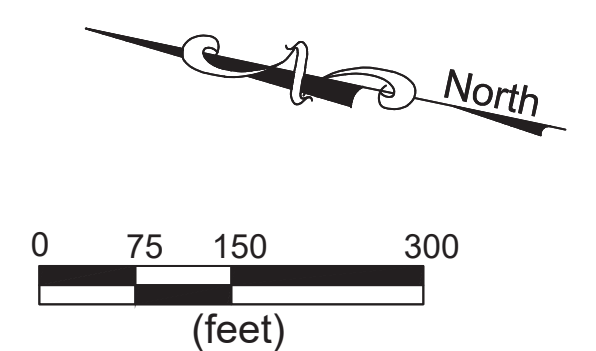
<b>COTTON, SHIRES AND ASSOCIATES, INC.</b> CONSULTING ENGINEERS AND GEOLOGISTS		
<b>ENGINEERING GEOLOGIC MAP</b>		
<b>MAR VISTA</b>		
DALY CITY, CALIFORNIA		
GEO/ENG BY AM	SCALE 1"=150'	PROJECT NO. G5019
APPROVED BY JW	DATE April 2019	FIGURE NO. 3

plotted an arcuate failure surface on our Engineering Geologic Map to determine if a new headscarp 150 to 200 feet inland could produce a reasonable landslide geometry and if that geometry was similar to what we see in the existing landslide. This estimated future headward expansion is shown on both the Engineering Geologic Map (Figure 3) and on Engineering Geologic Cross Section A-A' (Figure 4). It should be noted that the northern limit of the estimated future headward expansion was shifted inland to account for the potential influence of the southward expansion of the Olympic Club Landslide.

Based on this study and the previous slope stability analysis, it is our opinion that the line depicted on our Engineering Geologic Map is a preliminary estimate of a likely failure line, but should not be used to guide setback criteria at this time. This line is our best estimate of an appropriate setback from the limit of future landward advancement of the headscarp of the landslide. **This line does not represent a factor of safety of 1.5.** The only way to develop a building setback line for use in design is to perform a detailed site investigation including detailed mapping, subsurface exploration, laboratory testing and slope stability analysis. Such an investigation could generate a factor of safety line of 1.5 that shifts the potential building envelope farther from the bluff or closer to the bluff.
