**SKYLINE BLUFFS
DALY CITY, CALIFORNIA**

GEOTECHNICAL FEASIBILITY REPORT

February 12, 2019

8438.001.000

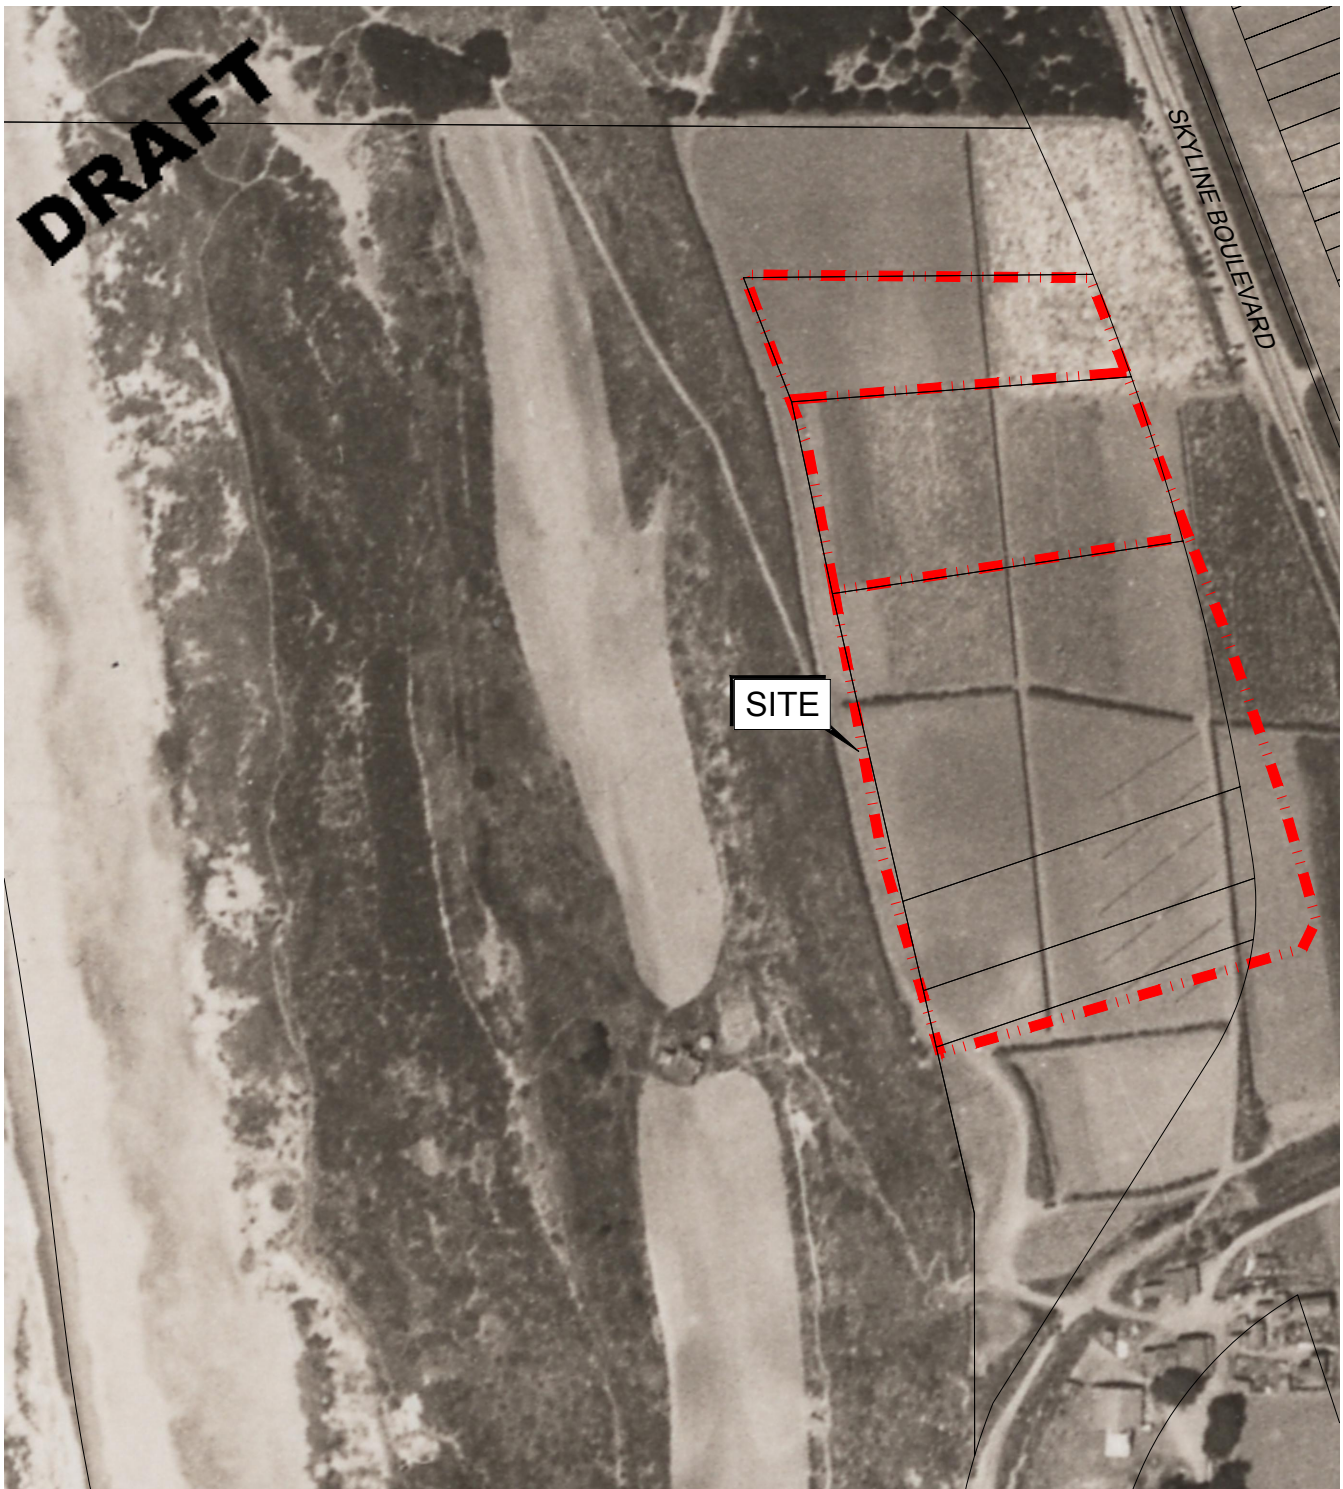
We reviewed stereo-paired aerial photographs of the site dated 1935 through 2001 (Figures 5A through 5G) and oblique photographs from the California Coastal Records project from 1972 to 2013 (Figures 6A and 6B). Review of these images indicates that in 1935 the site and an area on the landslide terrace below the site to the west appears to have been used as agricultural land. The existing stables were built between 1935 and 1943, in addition to structures on the southern two parcels. Improvements on the southern two parcels were removed between 1943 and 1965. A paved parking area was constructed on the landslide terrace west of the property between 1946 and 1965, with entry from John Daly Blvd. The parking area on the landslide terrace was demolished in 1983. According to various news article archives, the extension of John Daly Blvd. leading to the parking area was destroyed in a landslide in the 1982-1983 El Nino storms, and was not repaired. The aerial images show that much of the coastal bluff was sporadically vegetated prior to the early 1990s. In the 1993 aerial image, erosion and landslide failures in the coastal bluff appear to have accelerated, and erosion and landslide recession have continued to the present day.
